DEPARTMENT OF TRANSPORTATION**DIVISION OF ENGINEERING SERVICES**

Quality Assurance and Source Inspection

Contract #: 04-0120F4Cty: SF/ALA Rte: 80 PM: 13.2/13.9File #: 1.28**WELDING INSPECTION REPORT****Resident Engineer:** Casey, William**Address:** 333 Burma Road**City:** Oakland, CA 94607**Report No:** WIR-027619**Date Inspected:** 18-May-2012**Project Name:** SAS Superstructure**OSM Arrival Time:** 800**Prime Contractor:** American Bridge/Fluor Enterprises, a JV**OSM Departure Time:** 1830**Contractor:** American Bridge/Fluor Enterprises, a JV**Location:** Pier 7 Job Site**CWI Name:** N / A**CWI Present:** Yes No**Inspected CWI report:** Yes No N/A**Rod Oven in Use:** Yes No N/A**Electrode to specification:** Yes No N/A**Weld Procedures Followed:** Yes No N/A**Qualified Welders:** Yes No N/A**Verified Joint Fit-up:** Yes No N/A**Approved Drawings:** Yes No N/A**Approved WPS:** Yes No N/A**Delayed / Cancelled:** Yes No N/A**Bridge No:** 34-0006**Component:** S.A.S. Components**Summary of Items Observed:**

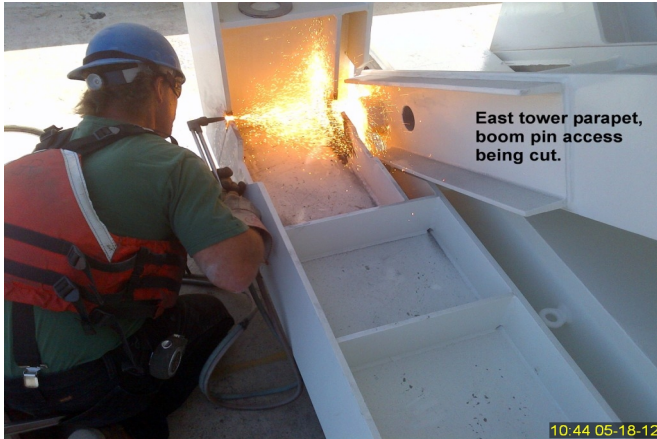
The QAI met with Transportation Engineer (TE) Mohammad Awal at the pier 7 warehouse. There was discussion of work in progress on the East and West tower parapets. The QAI was informed that per Request for Information (RFI) 2830R00. The QAI witnessed ABF personnel cutting out portions of the tower parapets to facilitate removal of the tower boom hinge bolt (pin). The QAI noted that at the end of the shift, the cope cuts had not been ground smooth. See the attached photo.
